# Delaware Nature Society

## Streamside Habitat Assessment

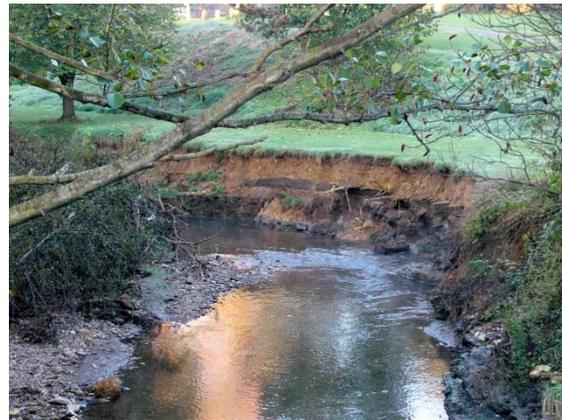
*Steep eroding stream banks are commonly a sign of excess water running into streams during storms.*
